ASBESTOS SURVEY FOR FORT POINT U.S. COAST GUARD STATION

Presidio of San Francisco

**Prepared by:
R.L. Stollar & Associates, Inc.
Urie Environmental Health, Inc.**

September 1991

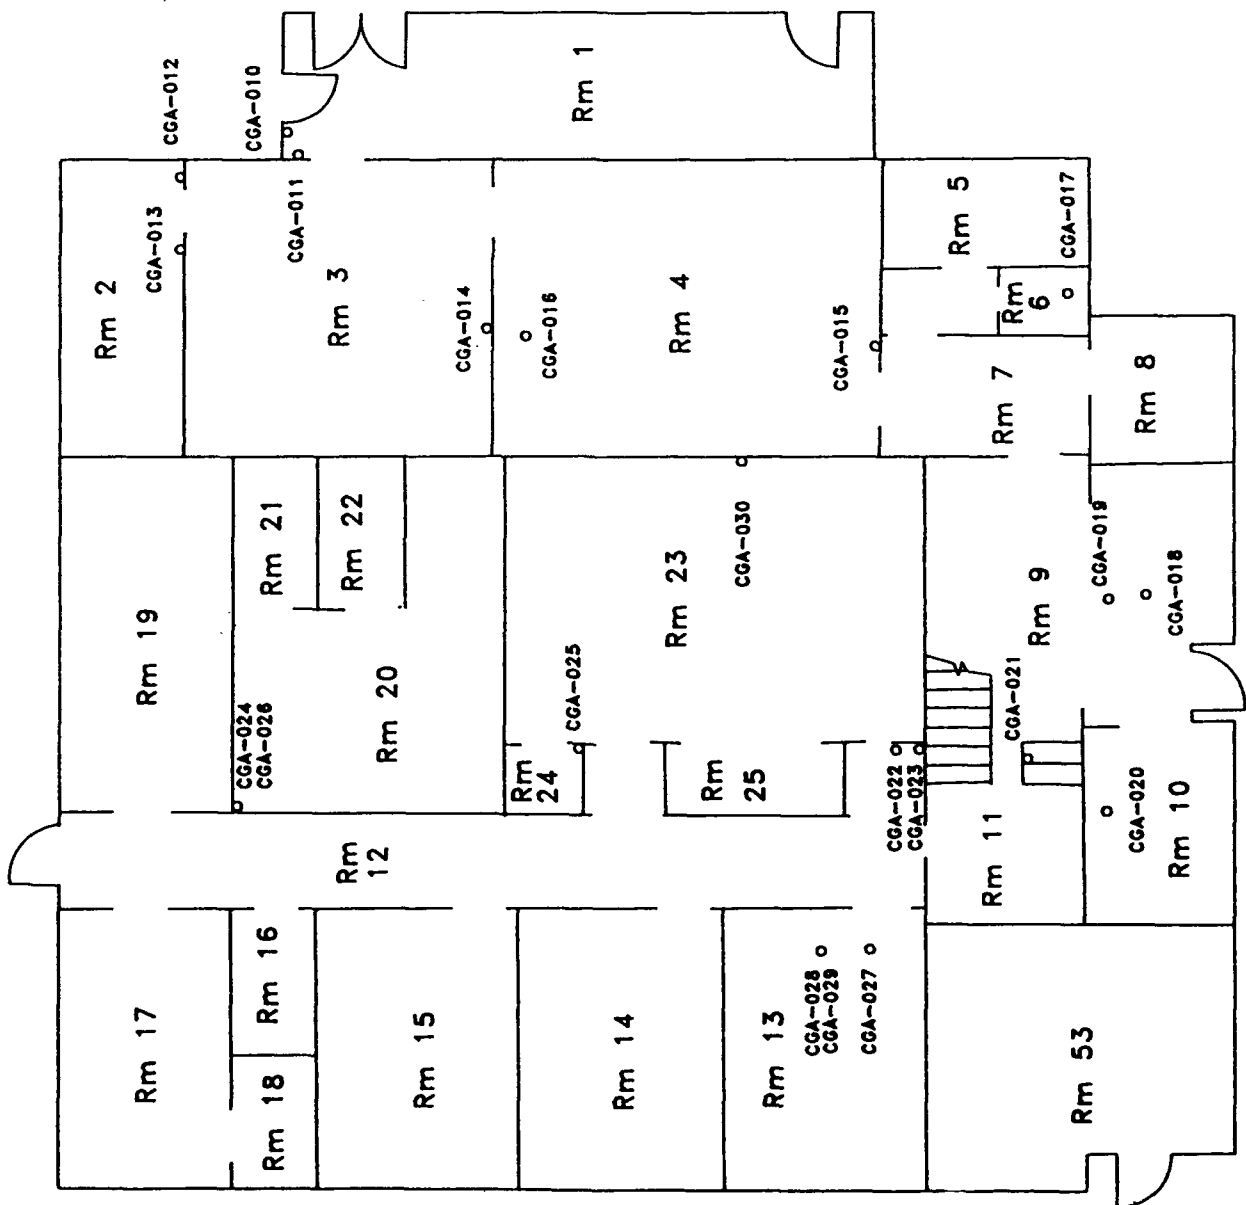
Figure 3.1-1

Building 991 is the former station house, a four-story, wood-frame structure with wood shake siding and roof, and has been recently reoccupied. A total of 75 functional areas including 55 rooms and closets, one crawl space, and 19 functional areas above ceiling panels were inspected. A total of 37 samples were collected, including 15 friable (table 3.1-1) and 22 nonfriable (table 3.1-2) samples, and sent to Versar for analysis. Figures 3.1-1 through 3.1-4 illustrate room and sample locations on each level. None of the friable samples collected tested positive for asbestos while one nonfriable sample tested positive. This sample, CGA-032, was a piece of linoleum floor material from the laundry room (Room 28, figure 3.1-2) and it contained 20 to 25 percent chrysotile asbestos. This particular type of floor material was found only in Room 28.

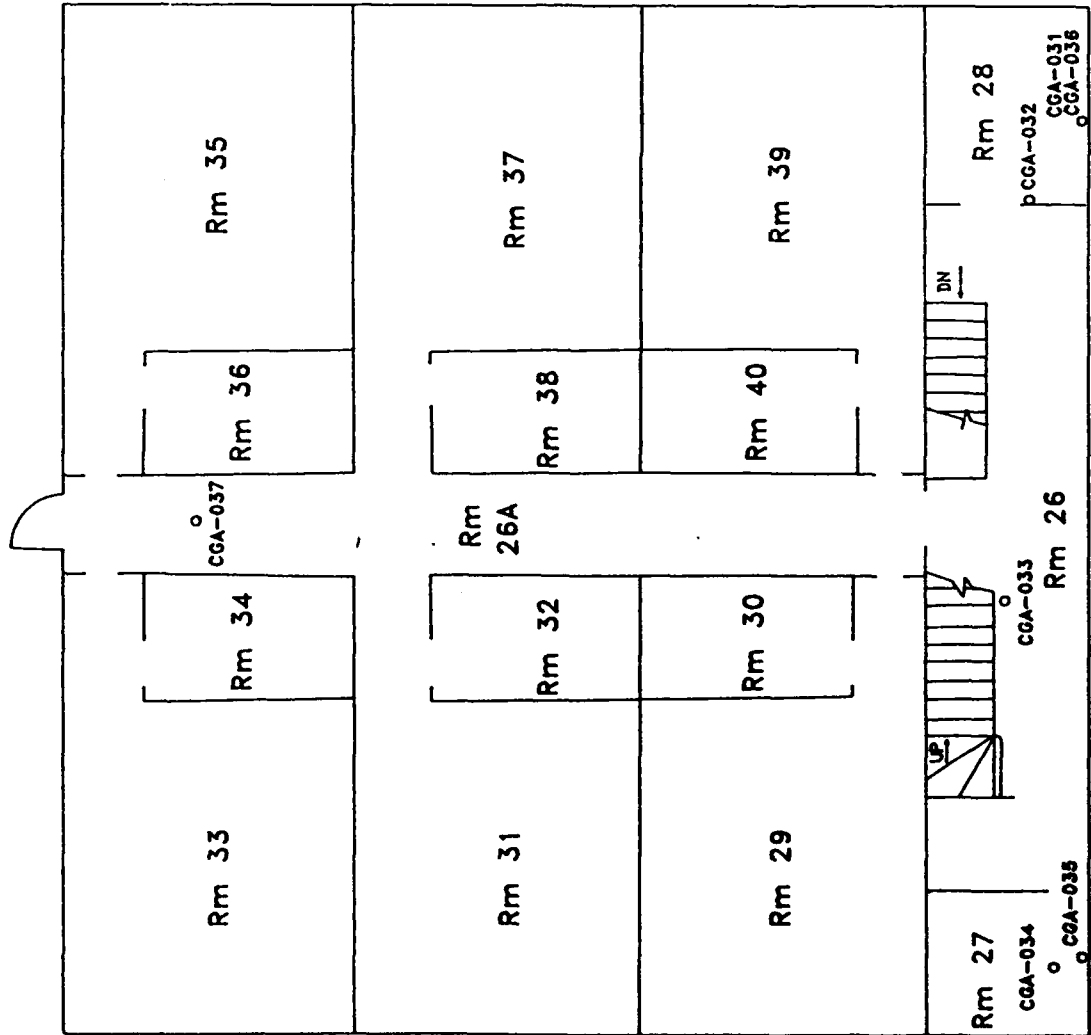
Figure 3.1-2

FLOOR PLAN & SAMPLE LOCATIONS
BLDG 991, SECOND FLOOR
FT. POINT U.S. COAST GUARD STATION
ASBESTOS SURVEY

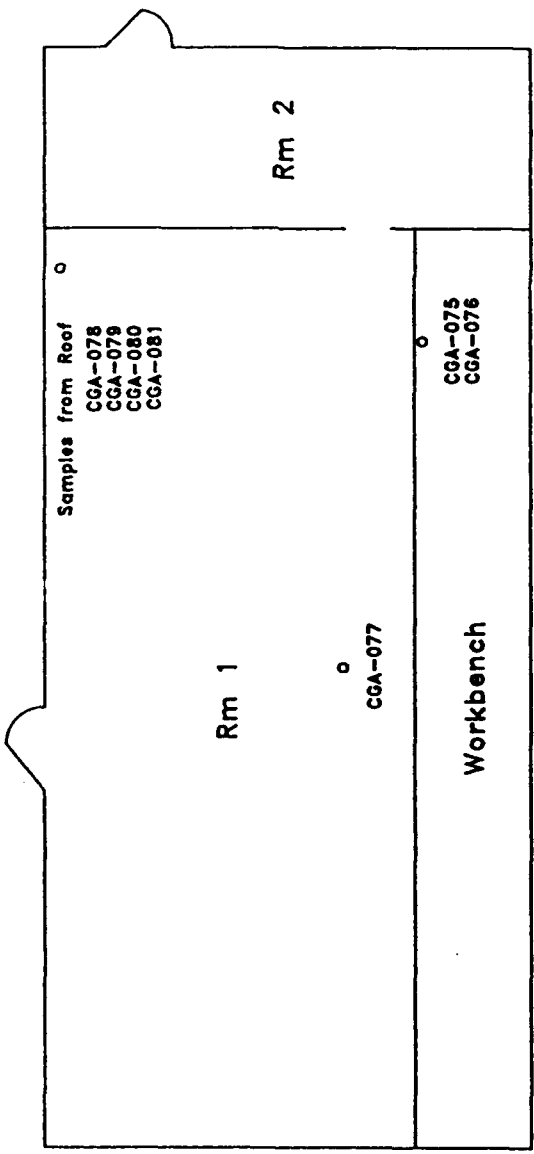
Building 998 is a former maintenance shop, currently vacant, located at the end of the pier (figure 1.2-1). This building is a wood-frame, one-story structure with wood siding and asphalt shingles. A total of three functional areas including two rooms and an attic were inspected. A total of seven samples were collected, one friable (table 3.8-1) and six nonfriable (table 3.8-2), and sent to Versar for analysis. Figure 3.8-1 illustrates room and sample locations on each level of the structure. No asbestos was detected in the friable sample while one of the nonfriable samples tested positive. Sample CGA-075 from the counter top tile in Room 1 contained 1-5 percent chrysotile asbestos. This tile is found in no other location in the building.

FLOOR PLAN & SAMPLE LOCATIONS
BLDG 988
FT. POINT U.S. COAST GUARD STATION
ASBESTOS SURVEY
